16.0 Shiprock, New Mexico, Disposal Site

16.1 Compliance Summary

The Shiprock, New Mexico, Disposal Site, inspected on August 15, 2007, is in excellent condition. Erosion along the southwest bank of the outflow channel requires repair. All other structures are in good condition. Research associated with cell performance that includes the collection of saturated hydraulic conductivity measurements, continued. DOE continues to study the effects of deep-rooted vegetation encroachment on the cell to evaluate the need for ongoing control. Scattered shrubs on the cell and in the outflow channel require additional treatment. Tumbleweeds and trash continue to accumulate along the perimeter fence and in the outflow channel area; removal is warranted in the outflow channel. No cause for a follow-up or contingency inspection was identified.

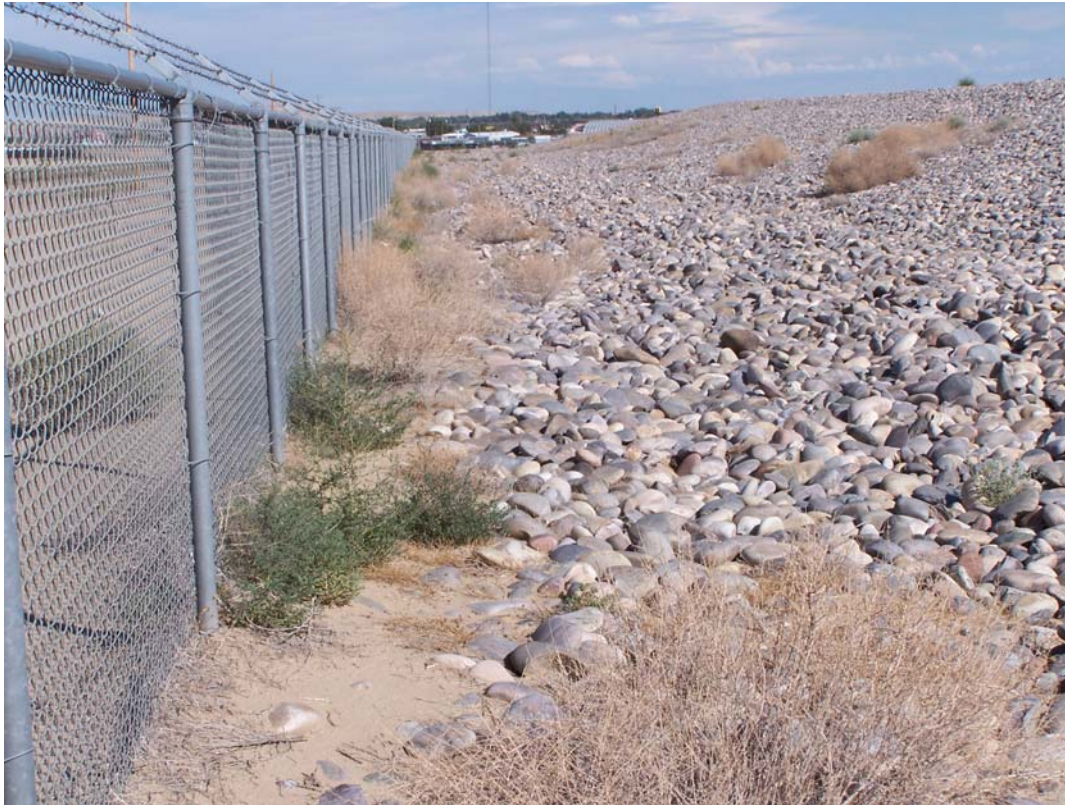
Small quantities of tumbleweeds and windblown trash have accumulated along the outside and inside of the southwest perimeter fence and in places outside the fence bordering the NECA yard. Windblown sand continues to accumulate along the southwest side of the disposal site and, to a lesser extent, in other areas (PL–1). This sediment allows for growth of annual weeds and shrubs. Tumbleweeds and trash have also accumulated on the outside perimeter fence in the outflow channel (PL–2). This debris could potentially impede water flow in the channel and will be removed in 2008. DOE will continue to monitor and remove significant tumbleweed, trash, and windblown sand accumulations on site.

SHP 8/07. PL-1. Windblown sand and sediment buildup along the southwest perimeter fence line.

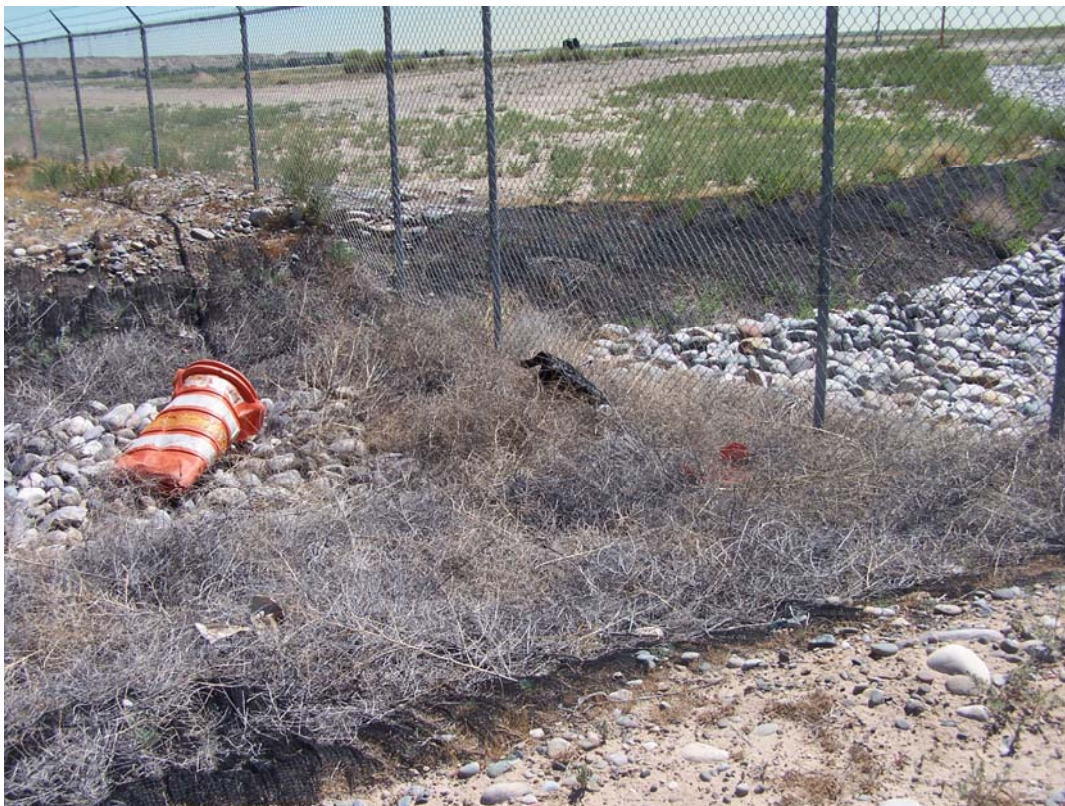
SHP 8/07. PL-2. Debris accumulation along the outflow channel fence.

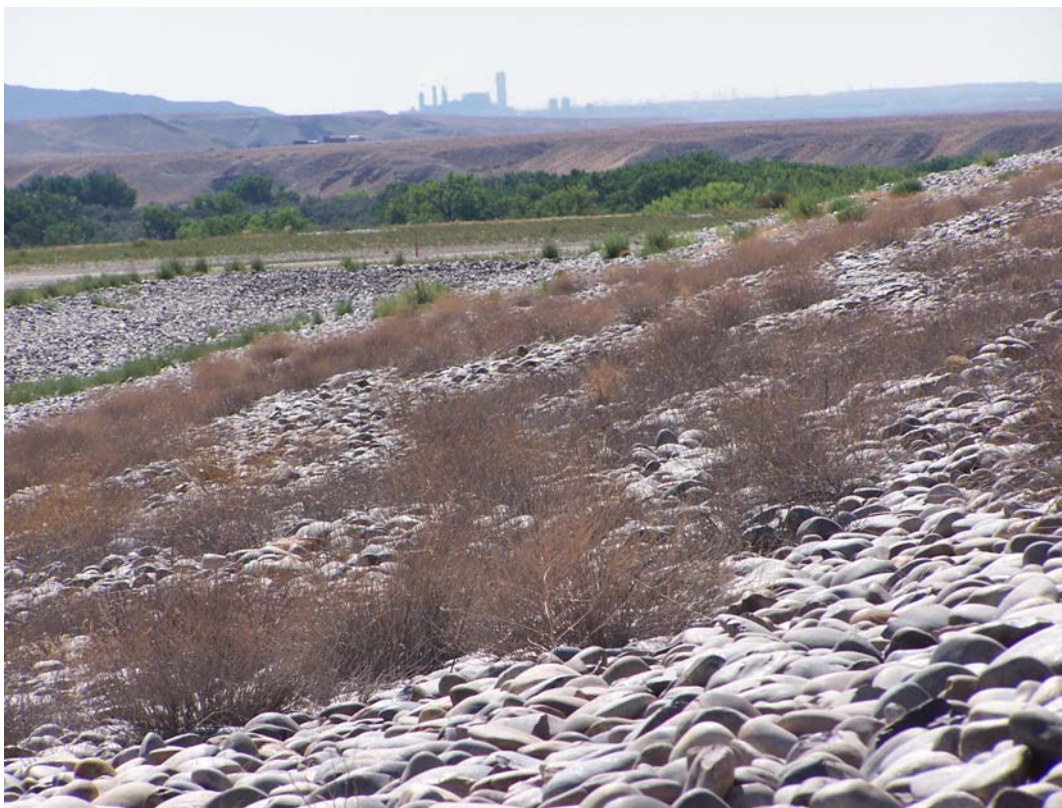
Woody vegetation in the outflow channel has been treated with herbicide in past years. The 2006 herbicide treatment was highly effective, with an estimated 95 percent kill (PL-3). Several patches of deep-rooted vegetation remain and are noted on Figure 16-1. Most of the vegetation on the cell is composed of shallow-rooted vegetation. Several noxious weeds were found and pulled by hand during the inspection.

SHP 8/07. PL-3. Treated vegetation on the northeast side slope of the cell.

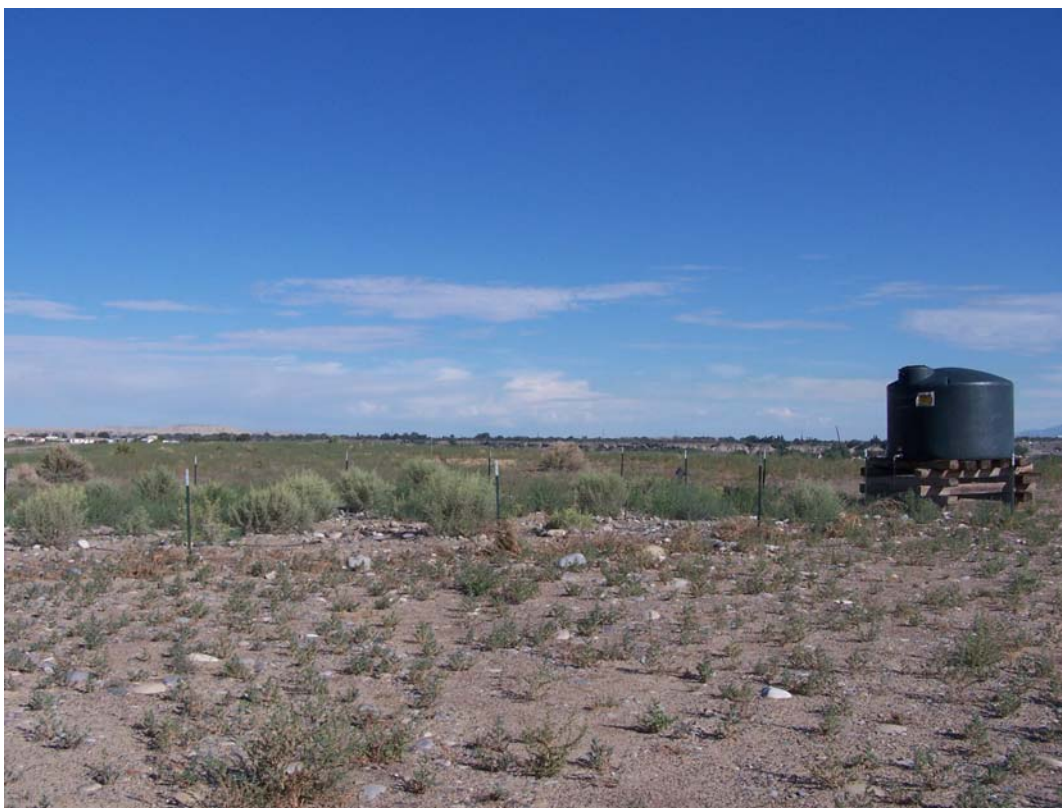
16B Two test plots that demonstrate plants useful for phytoremediation continue to collect data on the northeast side of the terrace (PL-4). The purpose of the testing is to demonstrate the effectiveness of using phreatophytes for removing former processing-site legacy ground water contamination from the terrace. The experiments will last from 3 to 5 years.

SHP 8/07. PL-4. Southern phytoremediation test plot.
